CONSERVATION OF TOMB OF KHAN-E-DAURAN

DEPARTMENT OF ARCHITECTURE
U.E.T, LAHORE

CONDITION SURVEY

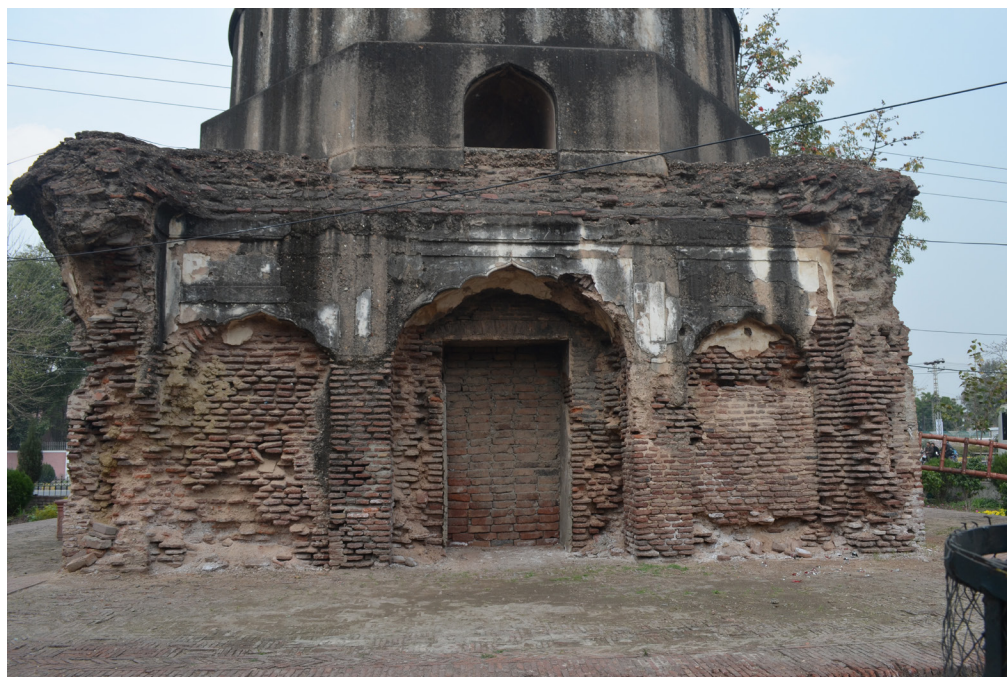
PLAN

The tomb rests on a podium measuring 46'-3" square. The tomb's chamber is square in plan measuring 25' square on the exterior and 13'-6" square in the interior. There are four openings, one on each side. The south side opening was filled with brickwork during the last repairs. These openings were made wider in the exterior with shallow *Peshtaqs*, and smaller in the interior. The exterior arched openings are higher while internal openings are flat and low in height. The difference between *peshtaq* and the opening is treated with *qalib-kari* and finished with *khat kashi* and fresco paintings, traces of such finishes survive on

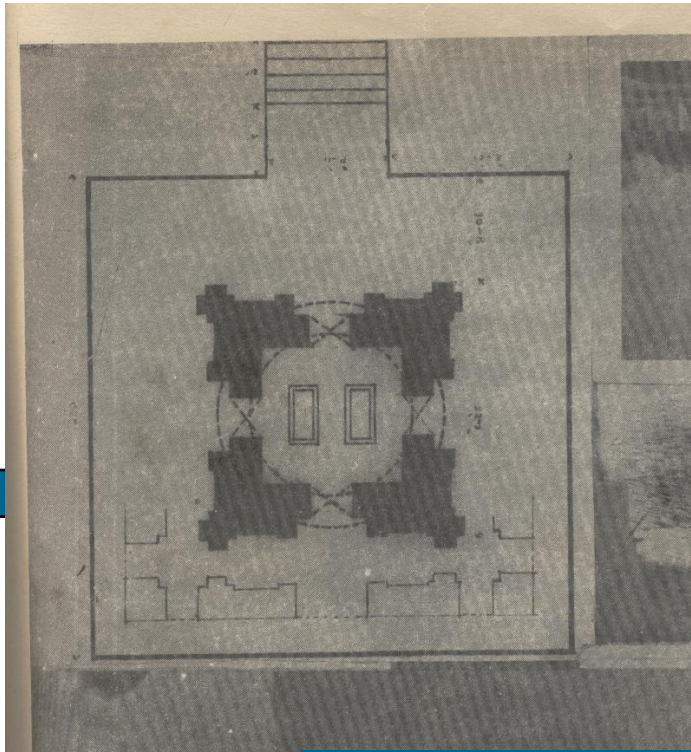
The plan at the level of zone of transition shows that a square plan has been converted into an octagon with squinch arches supporting the interior dome. Square plan meets the octagon and squinch arches at four corners to smoothly transit from a square form to a curved spherical dome. The external double dome rests on the walls outside these arches and is visible from some distance.

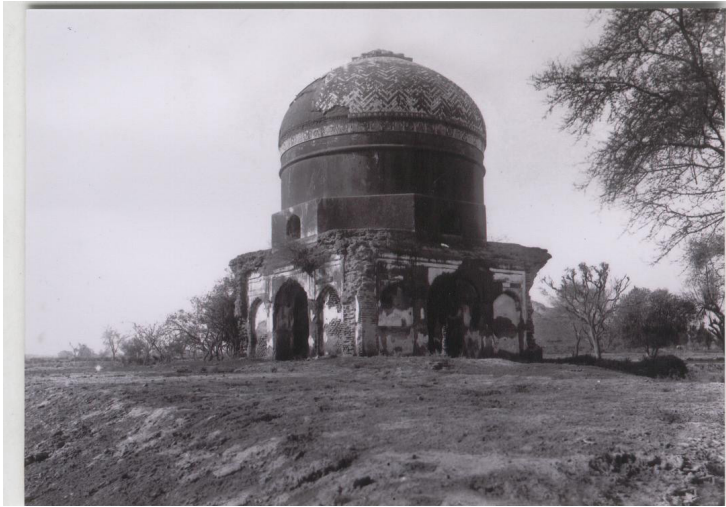
This picture was taken in early twentieth century (1920s) which shows that the platform at that time was covered in mud and clay. The tomb was located on an open patch of land with a few trees scattered all over the site. The verandah or the circumambulatory space around the tomb had fallen.

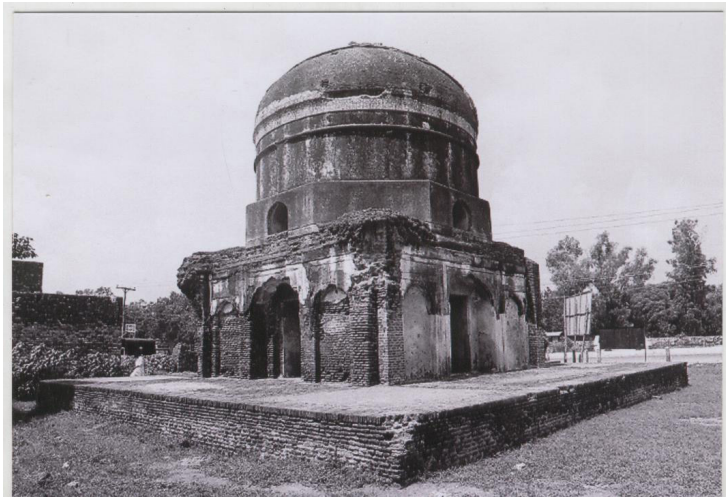
The picture on the lower left corner is also from the 1920s. Later in the same decade the clay was removed from the site and the platform was restored. Tiles from the dome were missing and most of the plaster had fallen. A signboard was placed to declare the site as a national heritage.

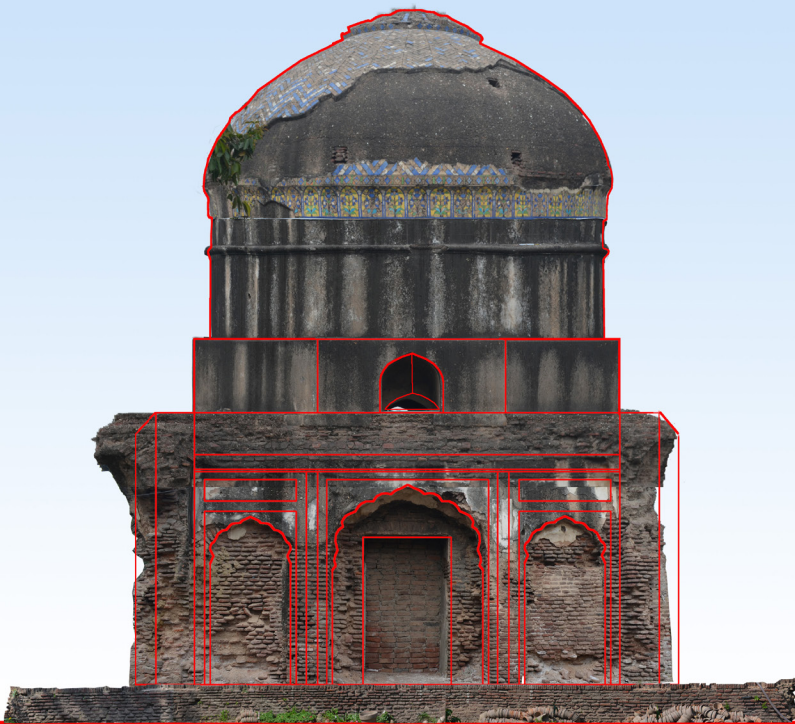
SOUTH ELEVATION

Beside cleaning and removal of unwanted decaying sources, south elevation needed serious vital restoration work. The corner pillars were badly dilapidated and most of the bricks on south wall had fallen.

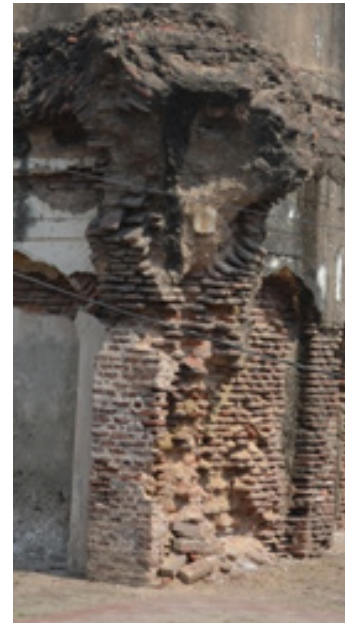
The pillars supporting the south side entrance had fallen as shown in the picture given below. Bricks were mostly, loosely bonded, leaving the structure vulnerable. As a first step these loose bricks needed to be replaced.

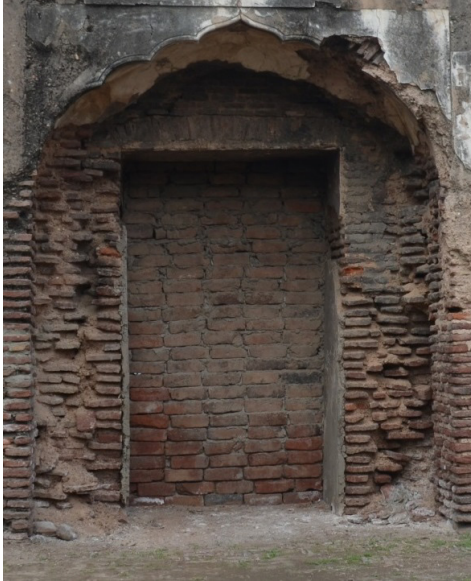
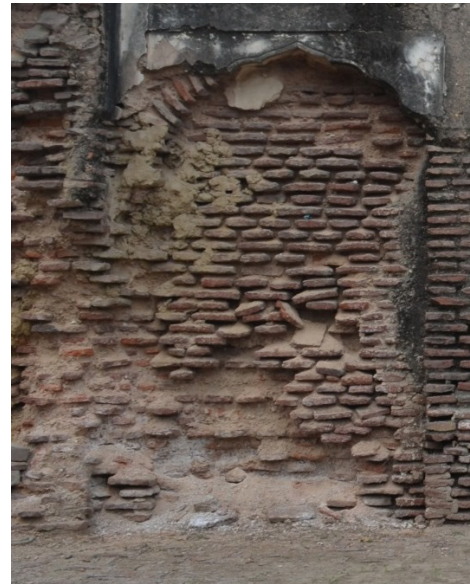
Negligence, age and other sources of decay and deterioration had dislodged plaster from many parts exposing brickwork underneath. Maintenance work done previously did not use original materials. The use of cement and concrete had further damaged the brick walls. Plaster was also wiped out over the arches exposing brickwork underneath .

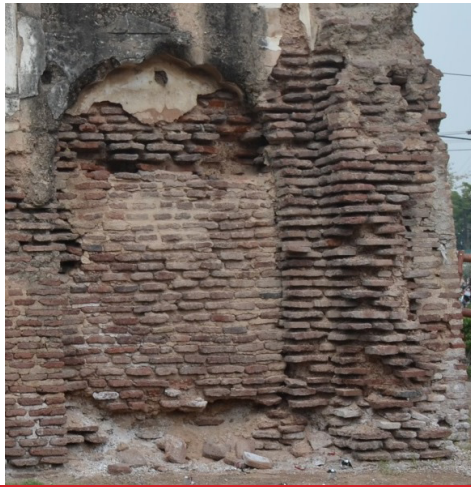
Arched niche located on the eastern side of the south facade shows a similar dilapidated state. Bricks have either fallen or are only loosely attached. The arch itself has been deformed to such an extent that it is difficult to understand both its geometry and shape. Once again it was the cement finish which was found to be the main reason for this quick distortion even after renovation work. This side required a large amount of reconstruction of brickwork apart from application of lime plaster.

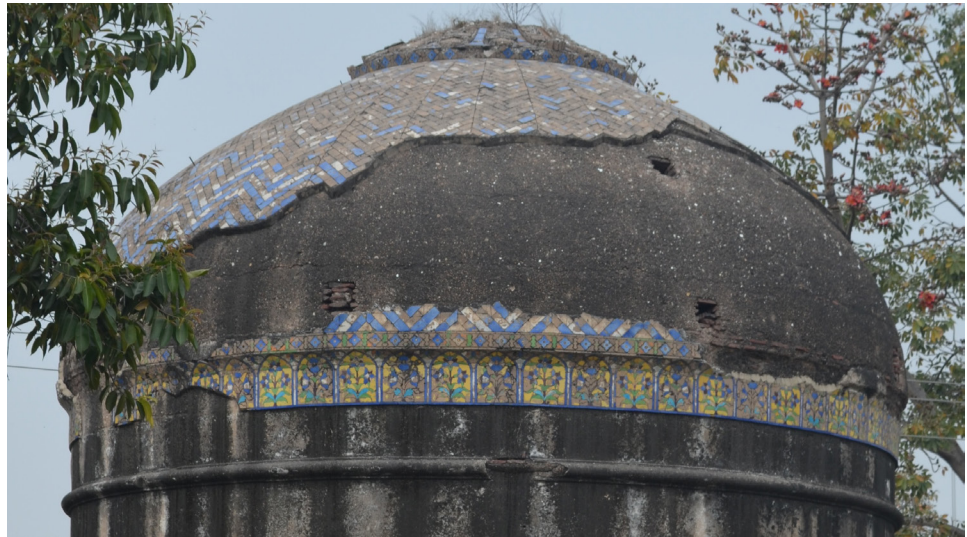
Tile-work on the dome's south side has mostly disappeared. Its top/pinnacle was also damaged and vegetation and grass could be seen growing on it which would worsen the condition over time. Cleaning of both the dome and the drum is required along with removal of carbon and vegetation over the drum and the dome if nothing else could be done.

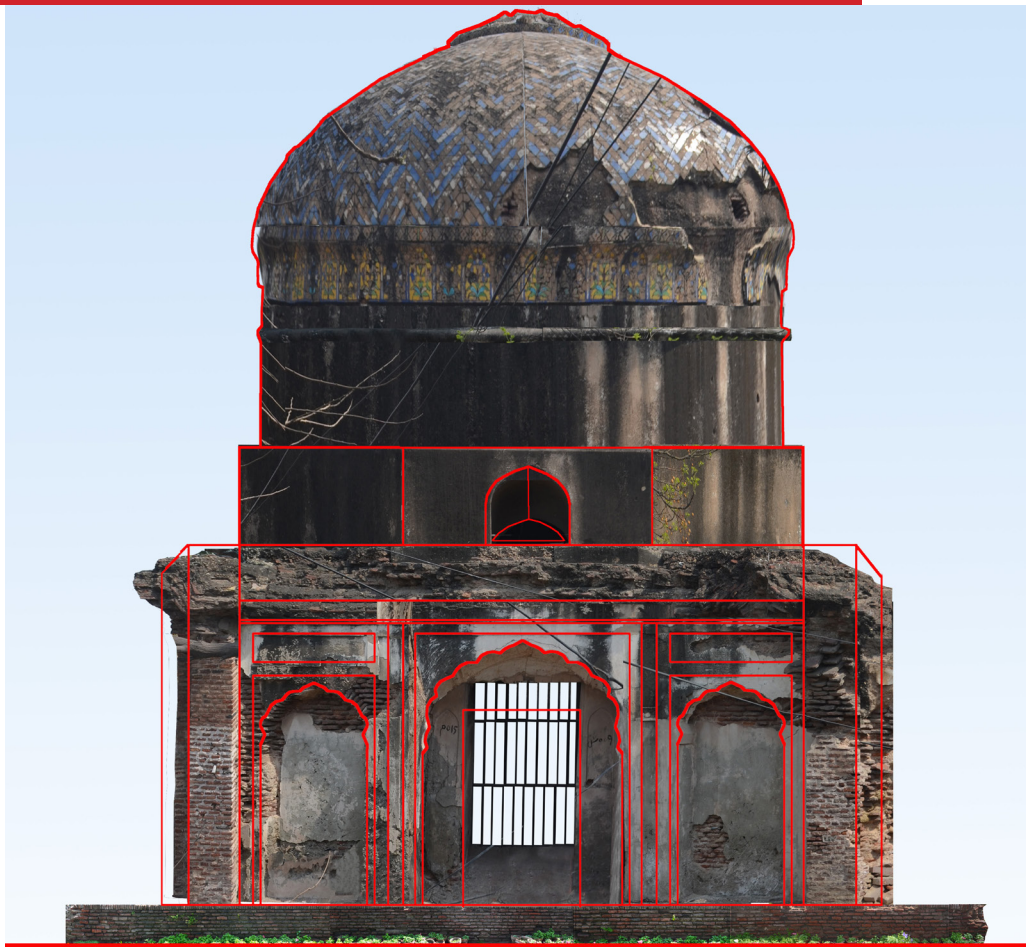
WEST ELEVATION

West side of the tomb does not present a better situation. This side of the dome was also in need of cleaning and fixing of damaged tiles to protect it from further deterioration. Glazed finish over the tiles had also eroded.

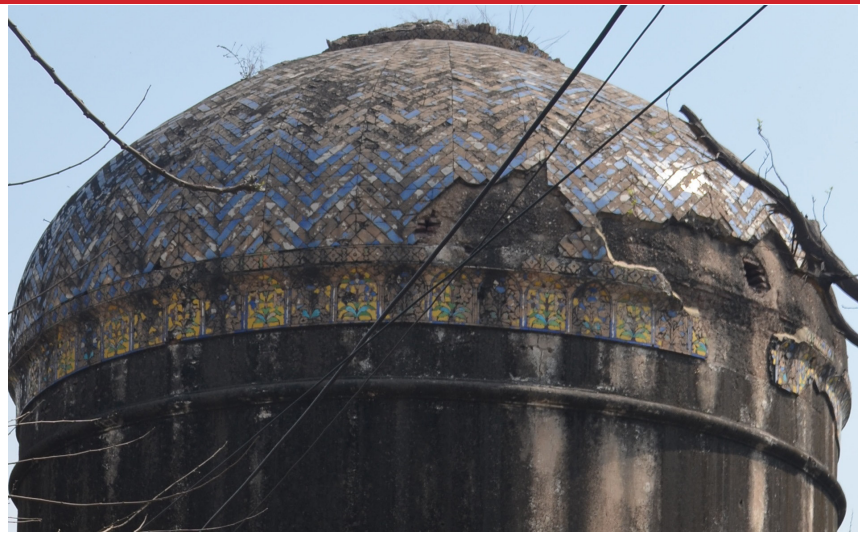
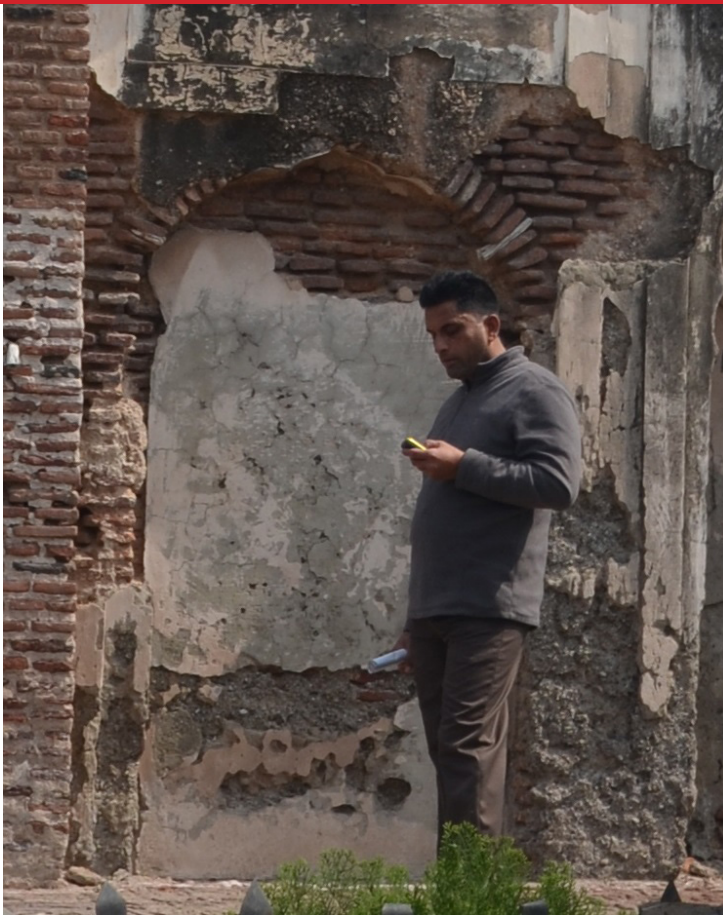
Both brick and plaster had deteriorated on the entire facade. The arched niches were in bad shape. The profile of the north-west arch was missing. The brickwork was loose and was hardly stable. The incompatible loose cement plaster needed to be removed. The brickwork required close inspection before the application of new kankar lime plaster.

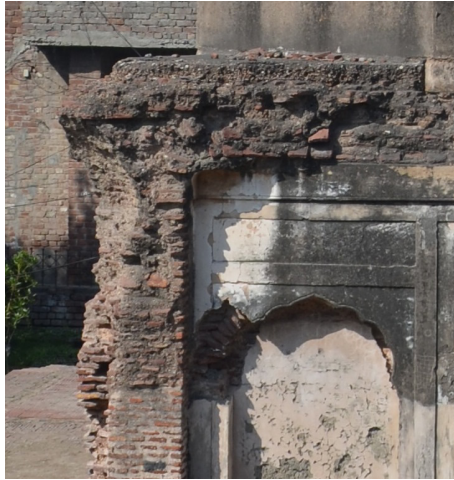
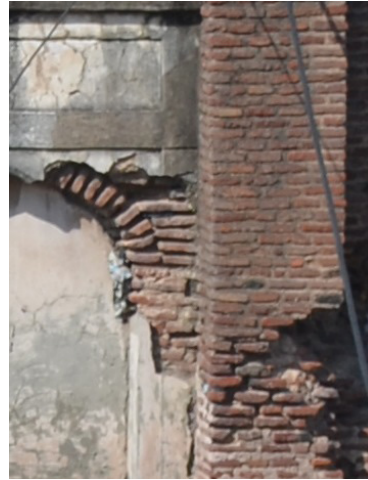
The brickwork on the east facade was relatively better but cement concrete plaster had deteriorated completely. Bricks had fallen from pillars and a few from the arches as well. After the removal of cement concrete plaster it was found that brickwork at a few places was in bad shape.

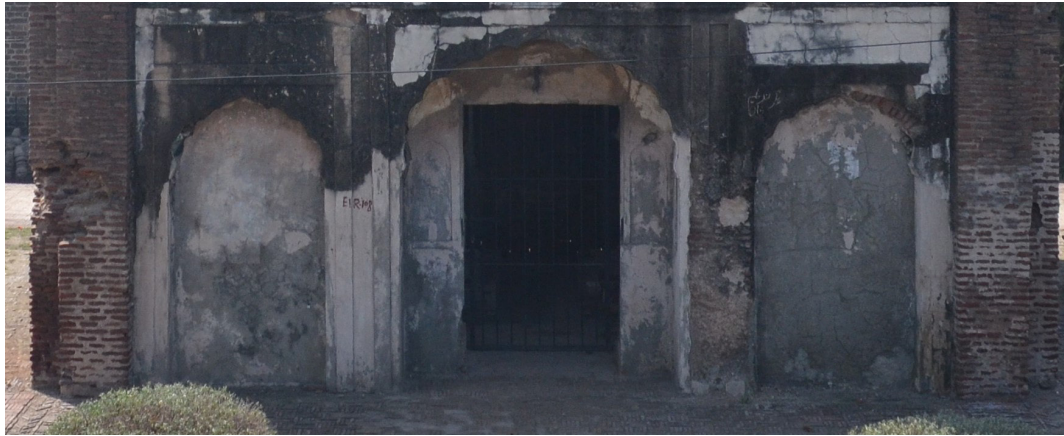
The brickwork on the north facade was in relatively good condition. However, cement concrete plaster was in bad shape. The exact profile of the multifoil arches executed in lime mortar was also broken. Brickwork was obscured by cement concrete plaster. After the plaster was removed it was revealed that the brickwork underneath was in bad shape. This unforeseen discovery increased the amount of labor and time which would be required to restore the building. It was also necessary to replace cement plaster and mortar by original kankar lime. In this way the building could be preserved for a longer period and require less maintenance as lime mortar gains strength with the passage of time.

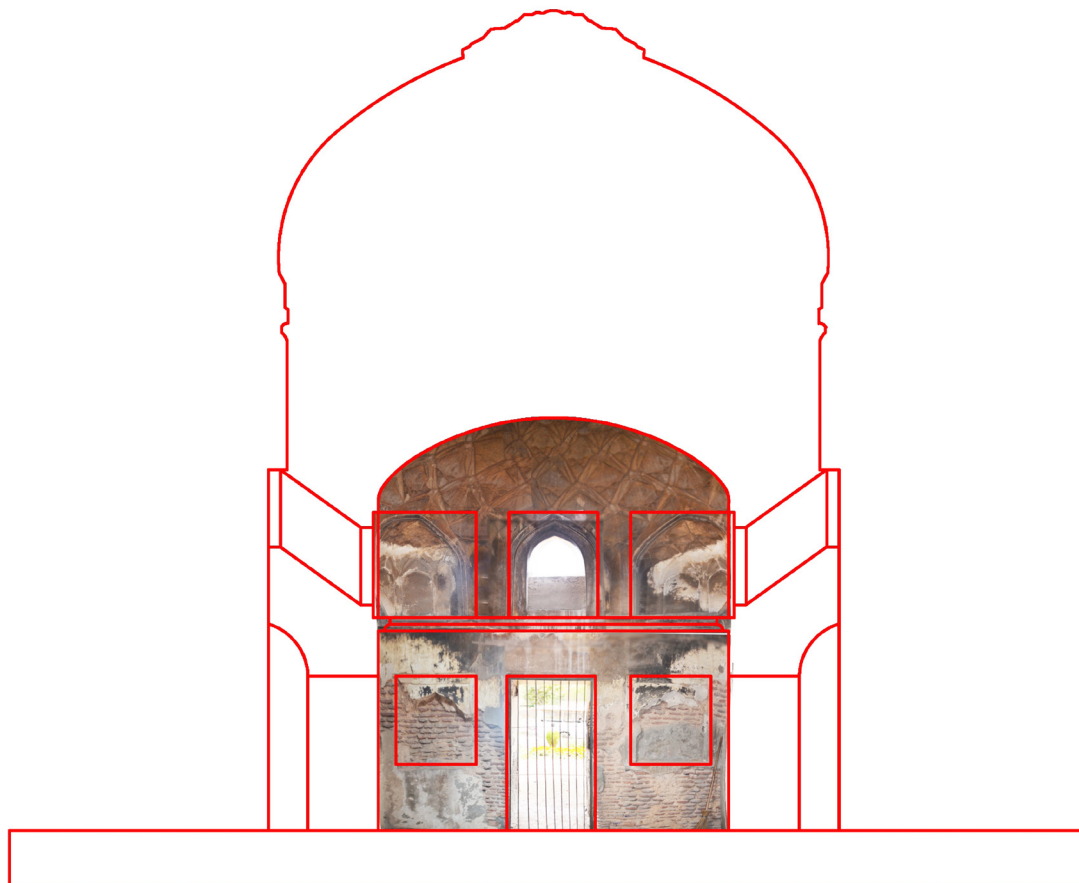
Section showing interior of North Wall

The condition of interior brickwork and cement concrete plaster was not any different from the exterior. The profile of multifoil arches over the niches was completely damaged. Negligence had greatly affected the structure from the inside as well. Most of the plaster had fallen from all sides and the brickwork was also in bad shape. Images below show interior of north wall on the left and east wall on the right. Both the walls required similar restoration work as was carried out on the exterior.

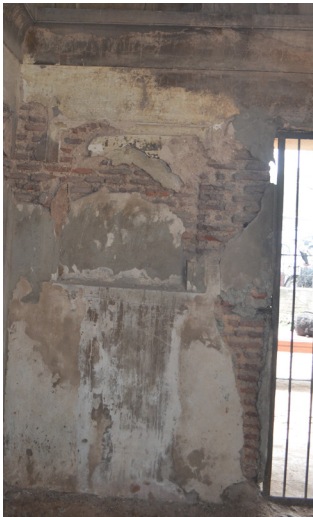
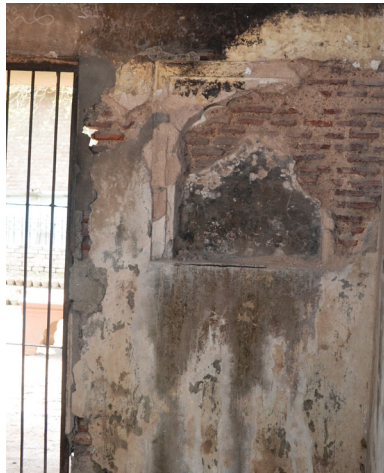
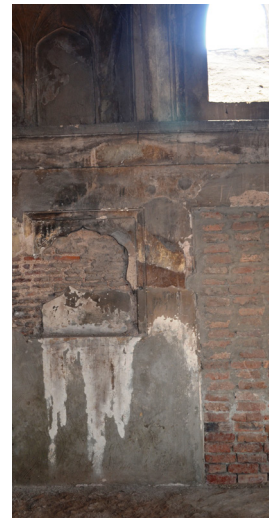
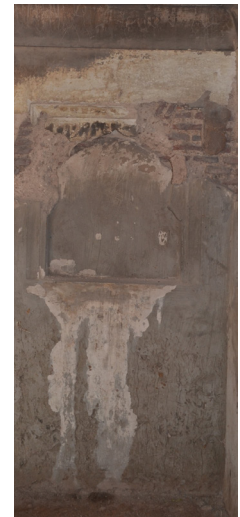
Images given below show the existing condition of the south wall on the right and west wall on the left. It is quite clear that the physical condition on all four sides is similar and needs removal of cement plaster and application of new lime plaster. Arches are also deformed and south entrance is blocked with modern size bricks.

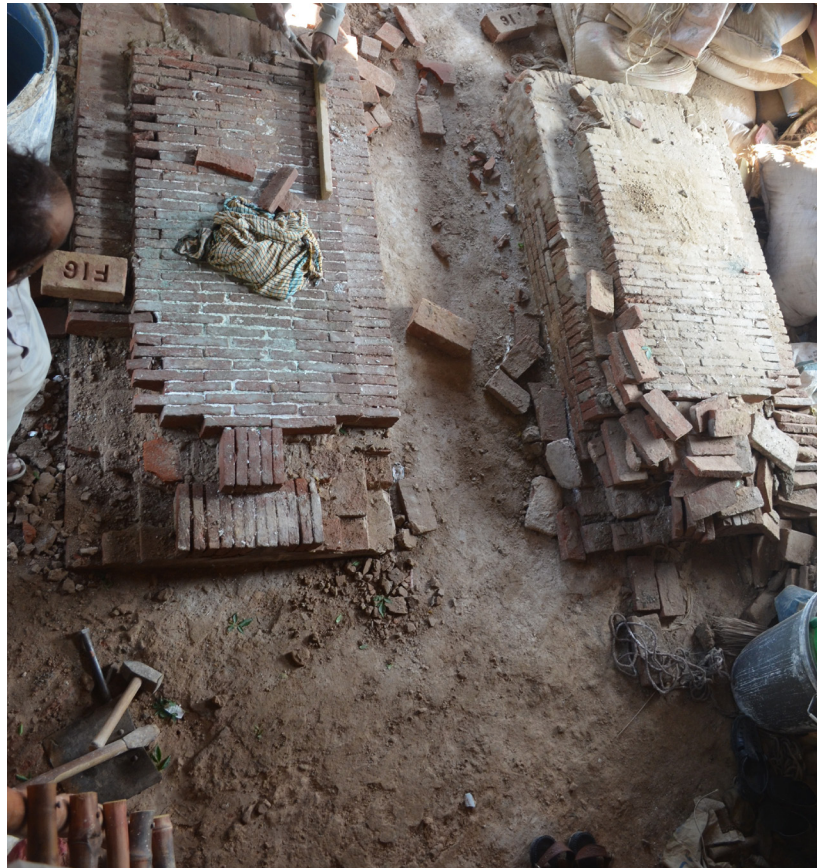
There are two graves inside the tomb chamber. These graves were built with traditional bricks and fell apart with the passage of time but were renovated and the bricks fixed. According to Chishti, Khan-e-Dauran built this structure as a final resting place for his wife but his son also buried him in the same structure soon after his tragic murder. According to Chishti Khan-e-Dauran rendered service as Nazim of Lahore for some time during the reign of Shah Jahan.

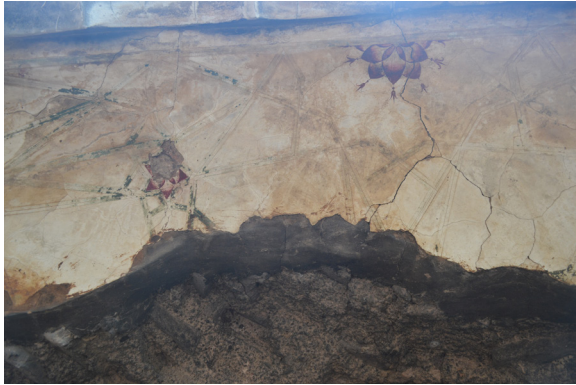
The traces of Qalib kari may be seen on arches of *Peshtaqs* while the fresco painting in deep red colour is still visible on the south side.

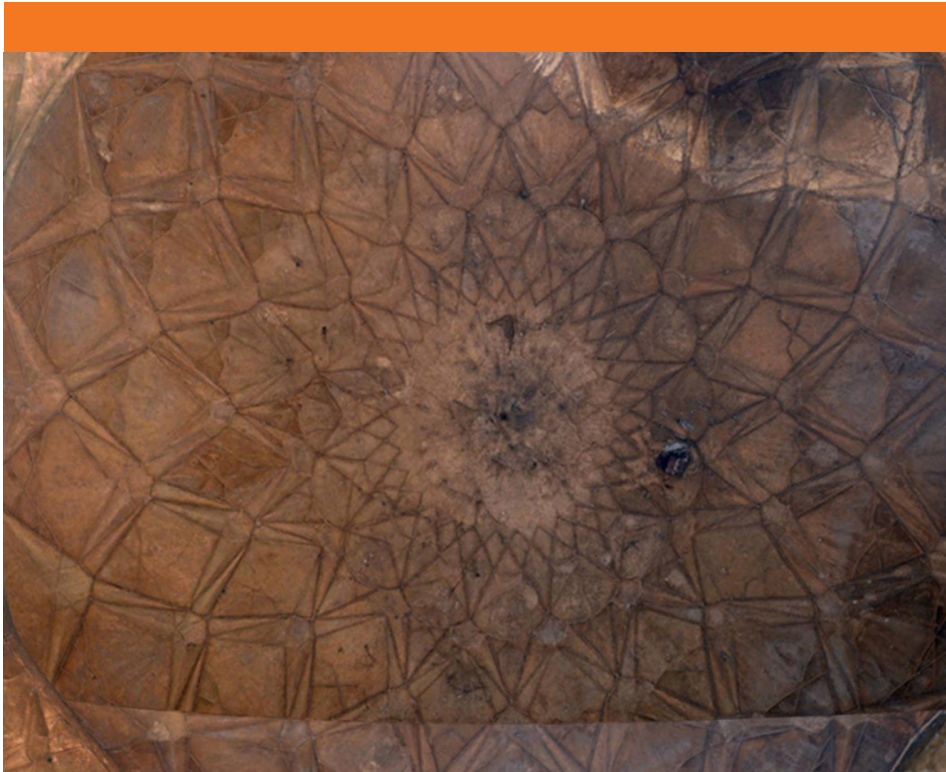
Qalib kari on the dome is similar to other structures as in the tomb of Dai Anga, and depicts a beautiful geometric pattern similar to modern computer-aided parametric design following strict geometric principles.

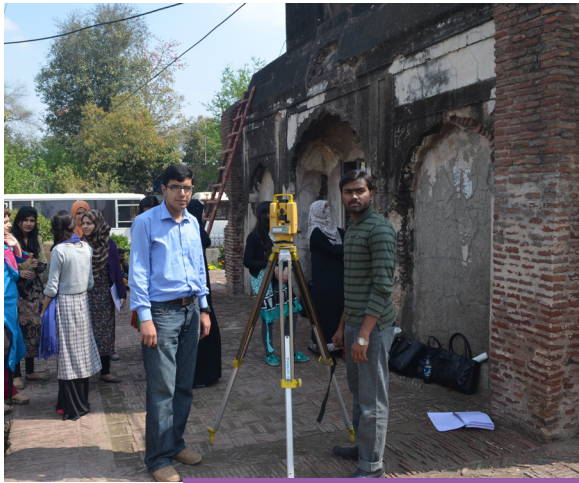
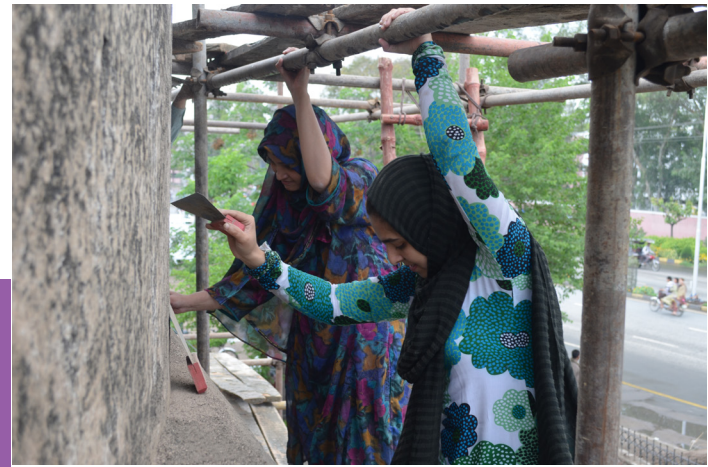
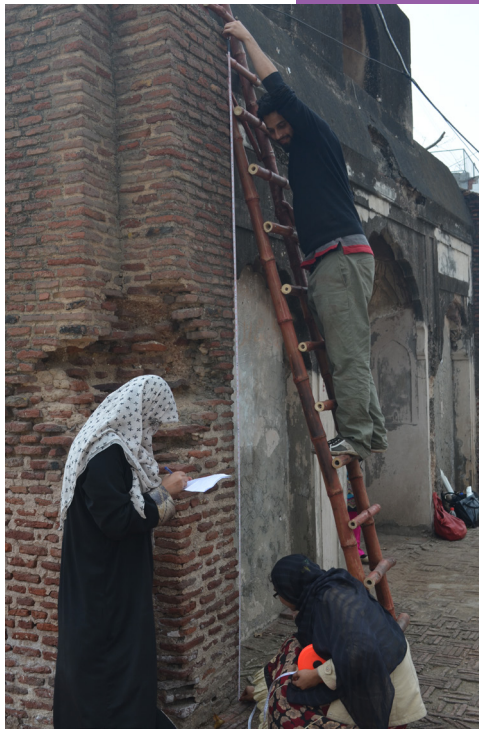
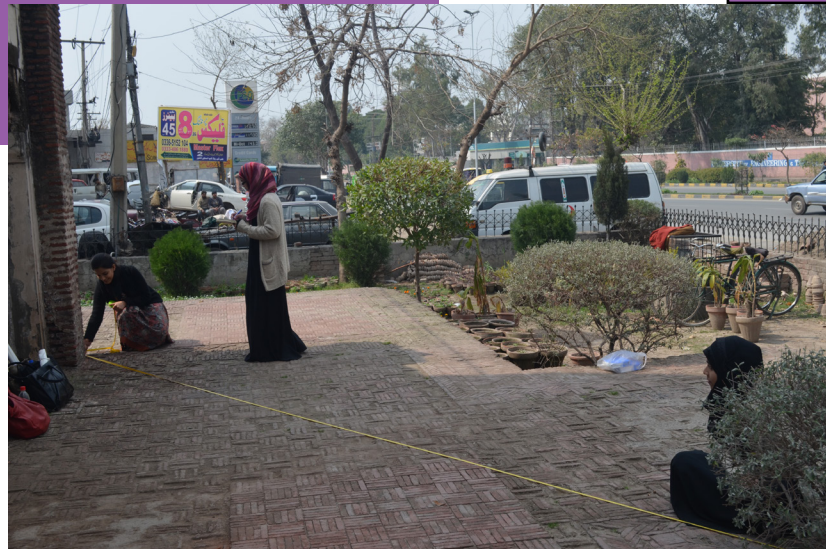
Pictures on this page show different stages of documentation and cleaning of the tomb. Students actively participated throughout the workshop and became part of the history of restoration of this tomb.
